Reference Number

Site Location

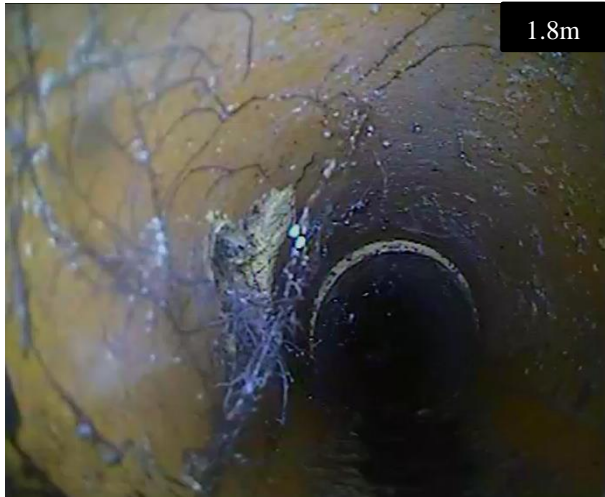
**Manhole D up branch connection 1.**

**1.8m**

**Hole in pipework at 9 o'clock and minor root penetration**

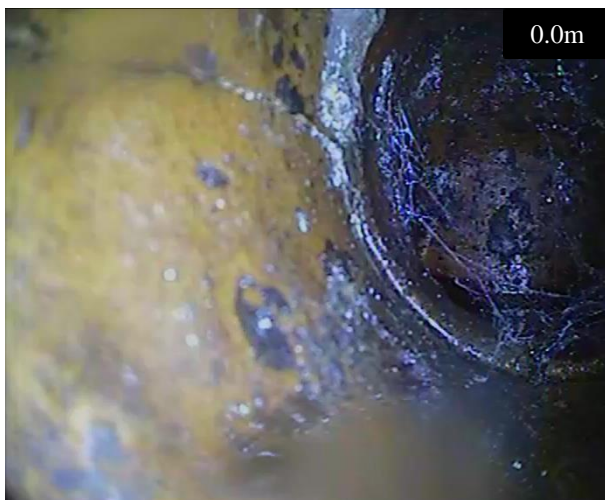
**Manhole D up branch connection 2 (high level).**

**0.0m**

**Longitudinal fracture to 0.1m**

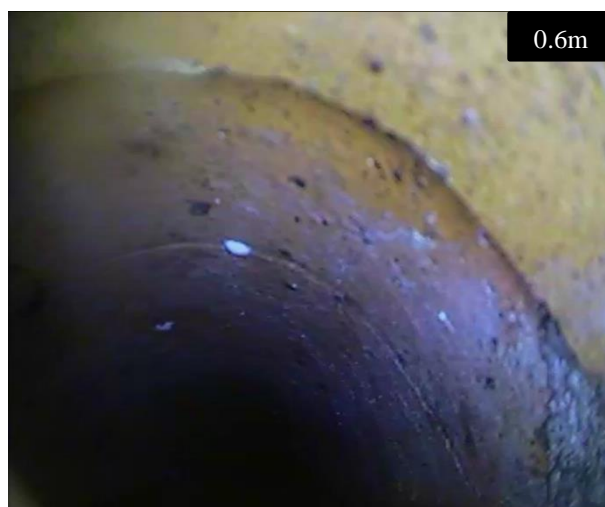
**Manhole D downstream.**

**0.6m**

**Joint, longitudinal fracture and radial fracture**

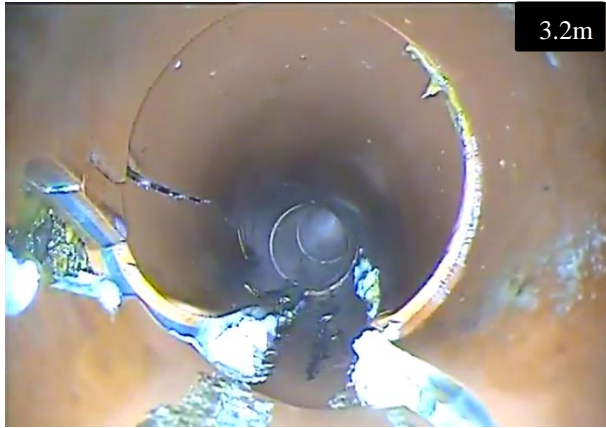
**Manhole B up branch connection 3.**

**3.2m**

**Broken pipework with sections missing. Please note pipework is on verge of collapse**

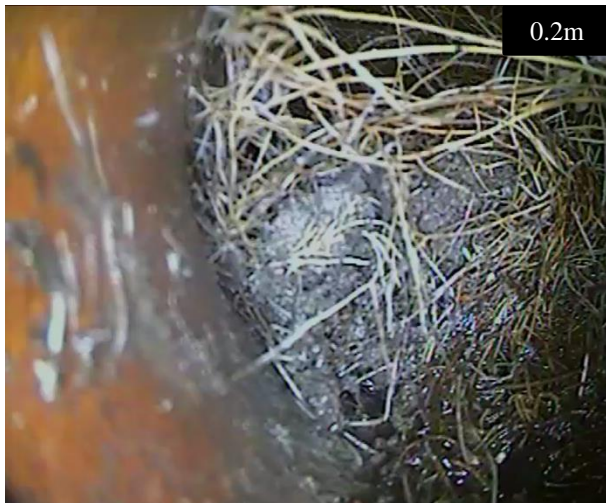
**Manhole B up branch connection 1.**

**0.2m**

**Root mass which prevented passage of the camera. Run is approximately 4.0m in total to basin waste gully**

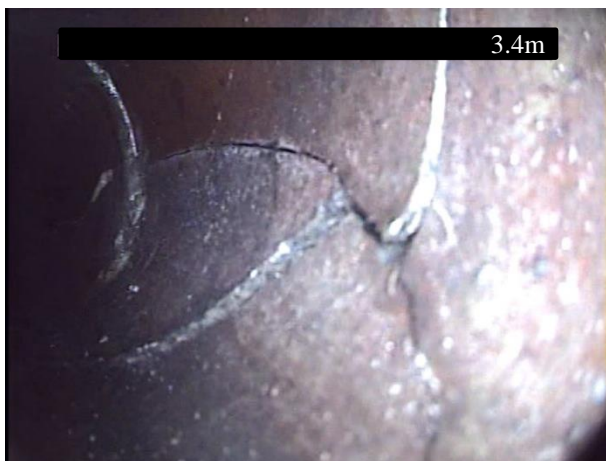
**Manhole E upstream to Rainwater Gully 2 (after high pressure water jetting).**

**3.4m**

**Multiple fracturing**

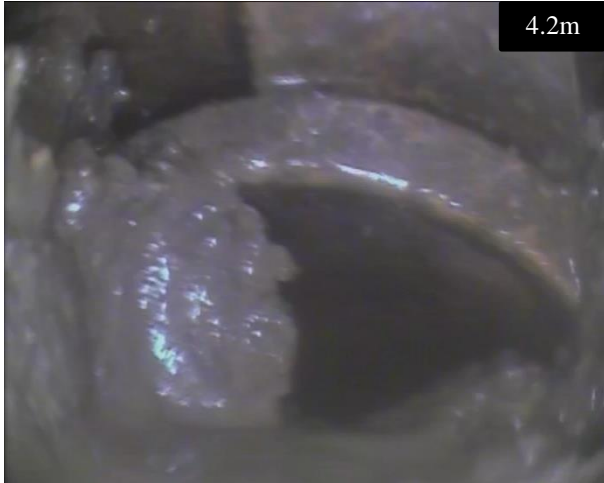
**Manhole E upstream to Rainwater Gully 2 (after high pressure water jetting).**

**4.2m**

**Severely dropped pipework which has collapsed. Run is approximately 5.0m to Rainwater Gully 2**

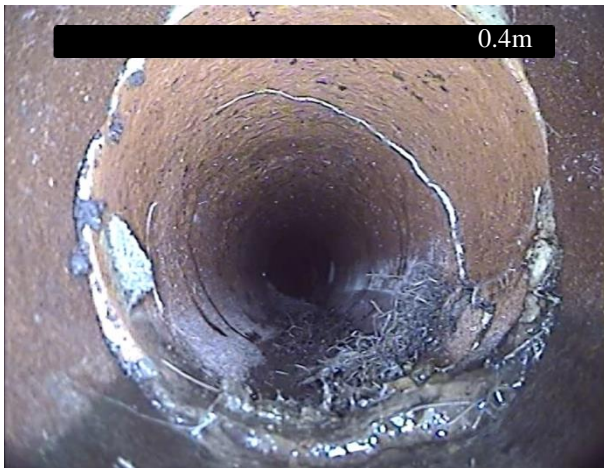
**Manhole E up branch connection to Rainwater Gully 1.**

**0.4m**

**Joint and root penetration**

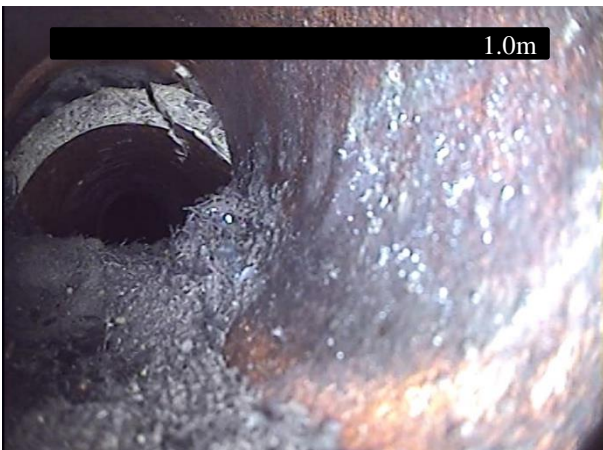
**Manhole E up branch connection to Rainwater Gully 1.**

**1.0m**

**Severe dropped pipework at joint, multiple fracturing and heavy root penetration which prevented passage of the camera. Run is approximately 1.8m to gully**

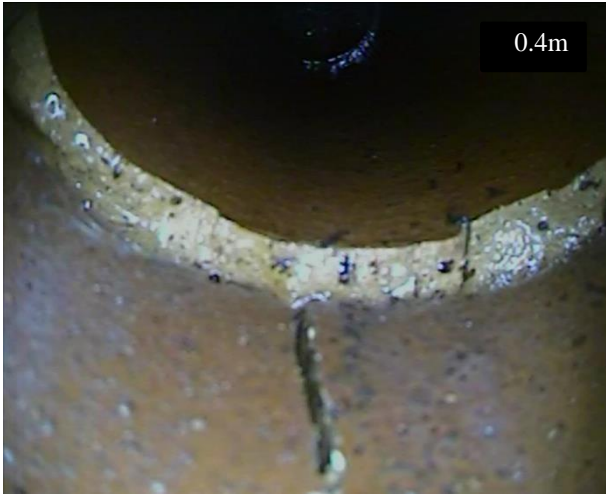
**Manhole E downstream to Manhole F downstream.**

**0.4m**

**Multiple fracturing at 6 o'clock**

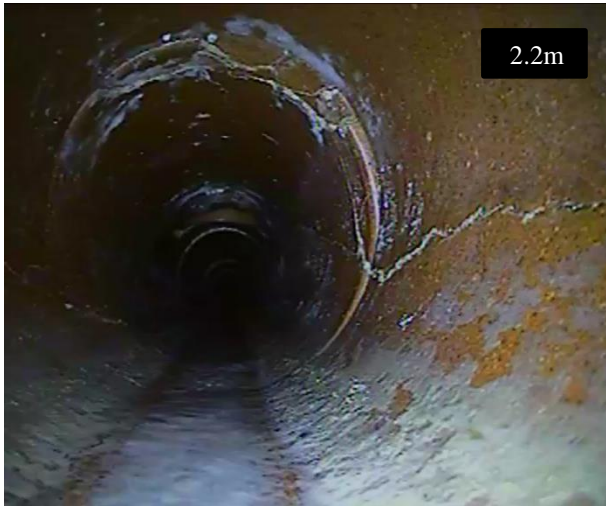
**Manhole E downstream to Manhole F downstream.**

**2.2m**

**Joint, longitudinal fracture and minor root penetration**

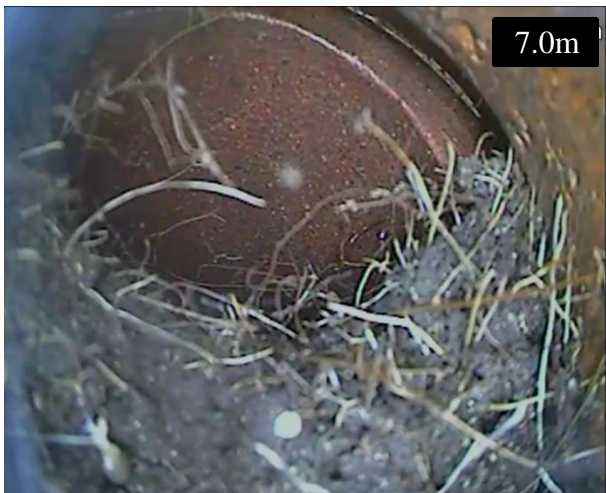
**Manhole E downstream to Manhole F downstream.**

**7.0m**

**Offset joint, root penetration and heavy debris deposits which prevented passage of the camera. Run is approximately 7.3m to Manhole F**
